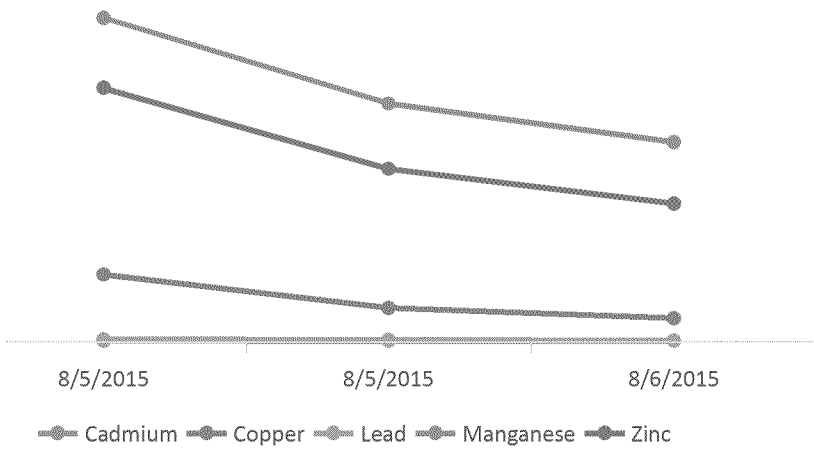
Location: CC48

ocation ID	Sampled	Cadmium	Copper	Lead	Manganese	Zinc
CC48	8/5/2015	30.6	2260	73.9	10900	8540
CC48	8/5/2015	19.1	1130	54.1	8020	5820
CC48	8/6/2015	14.2	786	30	6720	4650
